Brunswick Nuclear Plant – Larry Dunlap

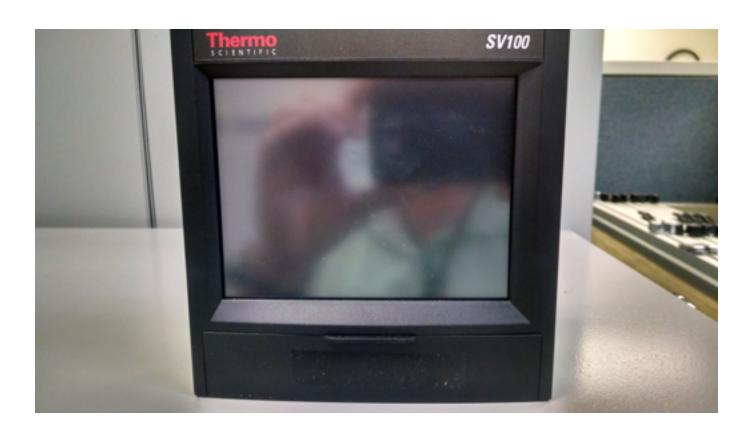
Repeated off/on power cycling from simulator scenarios from loss of power to equipment cause the screens on the SV100 digital recorders fail.
