WHEN PLANT DATA COMPARISONS GO ROGUE

**Scott Cupp
Arkansas Nuclear One**

Arkansas Nuclear One

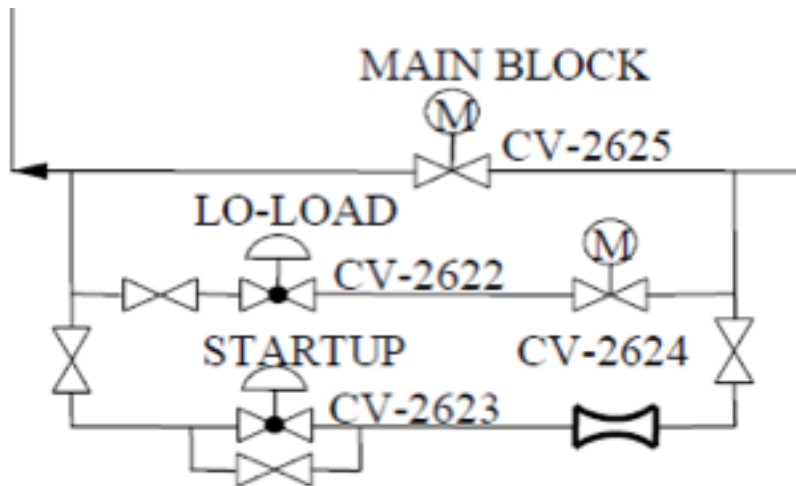
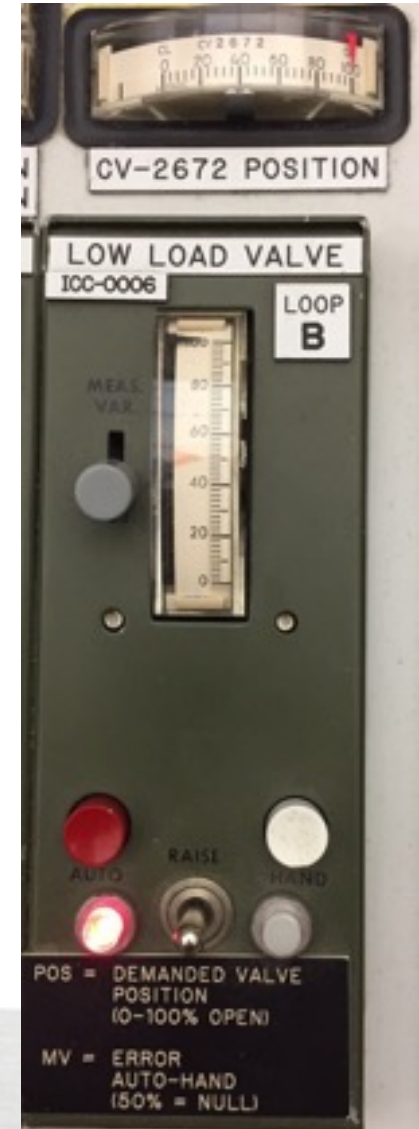
Three parallel feedwater flow paths:

- Startup flow control valves (6" air operated globe valve)
- Low load control valve (10" air operated globe valve)
 - LL/SU valves stop when main block opens / interlock
- Main feedwater block valves (>55%)

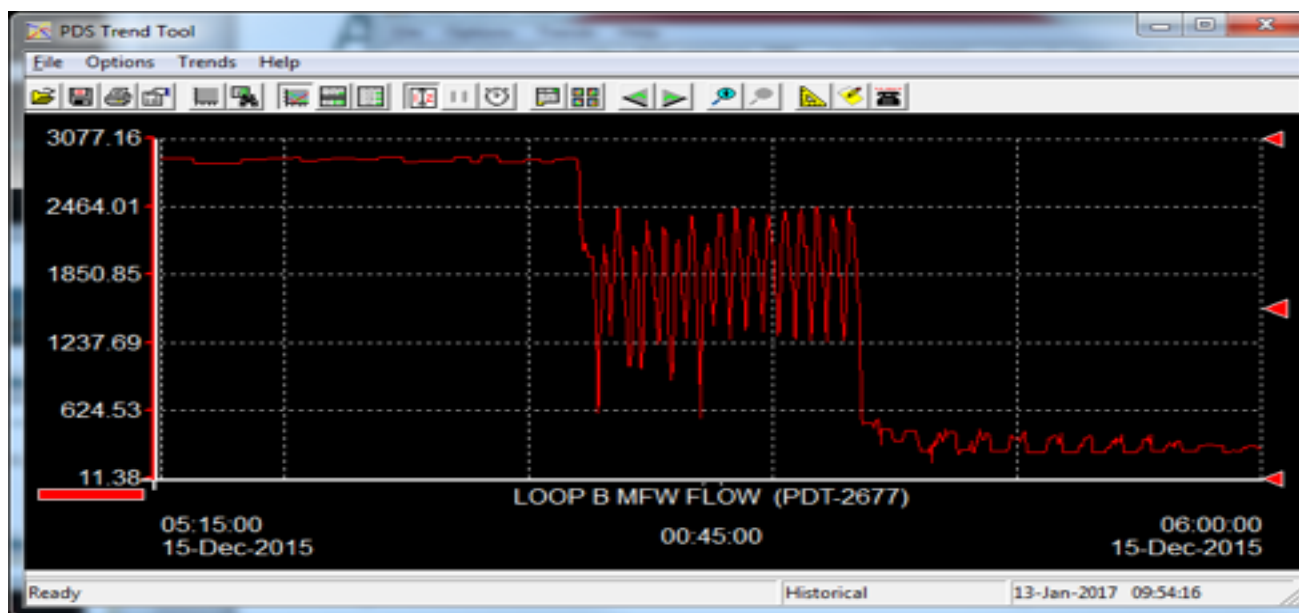
- ICS signal to begin closing B low load valve failed (equipment)
- Operators placed low load valves in manual but left the startup valves in automatic (human performance)
- Operators tried to manually close B low load valve to 90% but saw no immediate valve movement

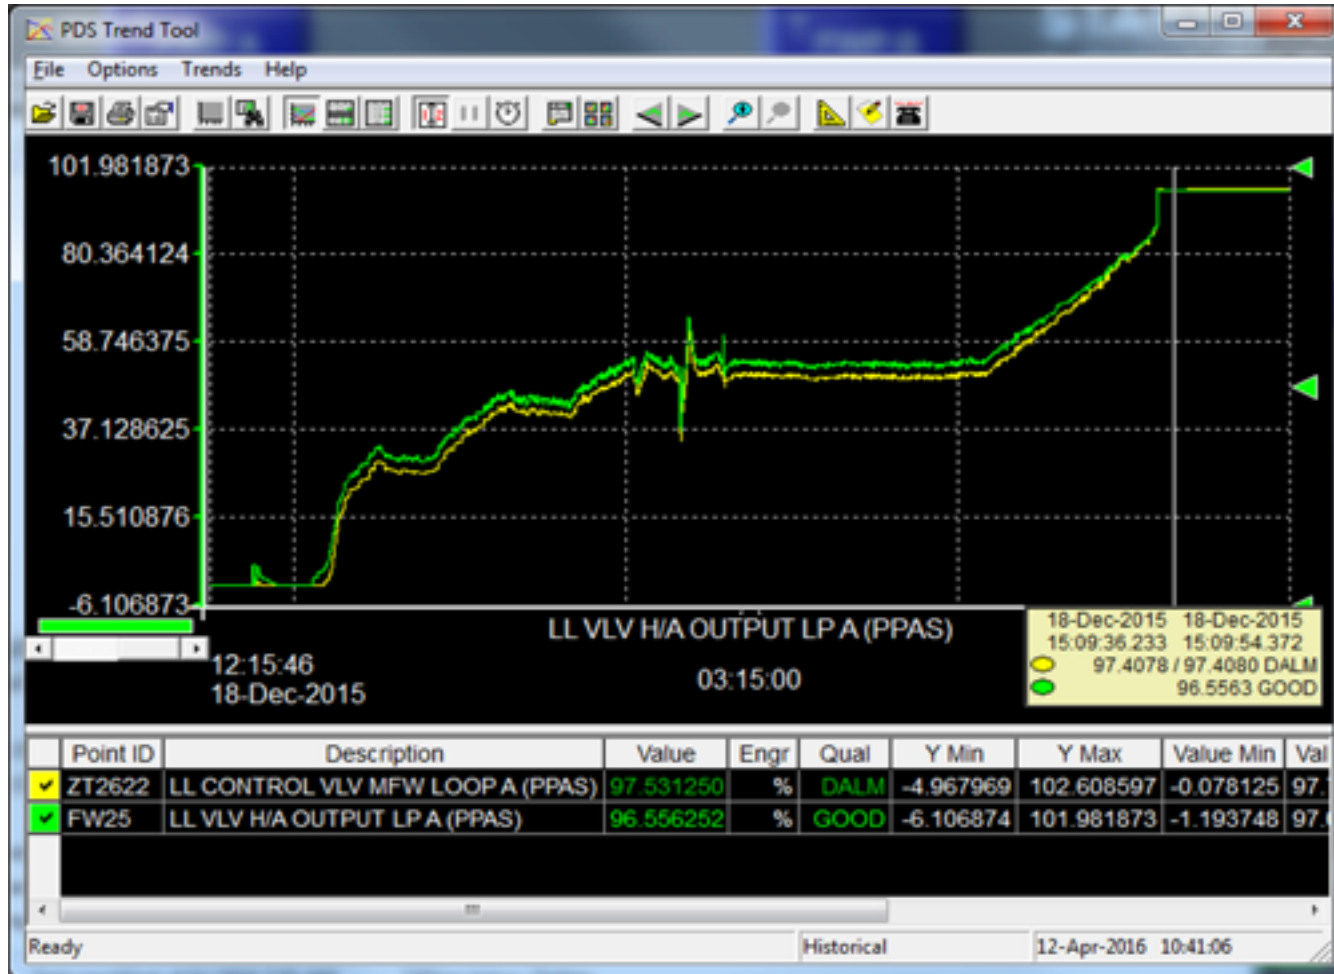
- No significant deadband existed
- Valve moved minutes after demand lowered (stuck)
- Maintenance discovered that valve positioner had drifted 7% over the current fuel cycle

- Root cause is revised removing simulator as issue
- NRC agrees no simulator issue exists
- QA agrees to revise audit report and determines simulator effectiveness is satisfactory
- Accreditation prep team eliminates draft SIF from ASER
