The Advancement of Simulator Models in the Age of “Technology”

HOW MICRO TECHNOLOGY HAS MADE POWERPOINT
PRESENTATIONS UNINTERESTING WITHOUT “FLARE”

MICHAEL M. PETERSEN
XCEL ENERGY

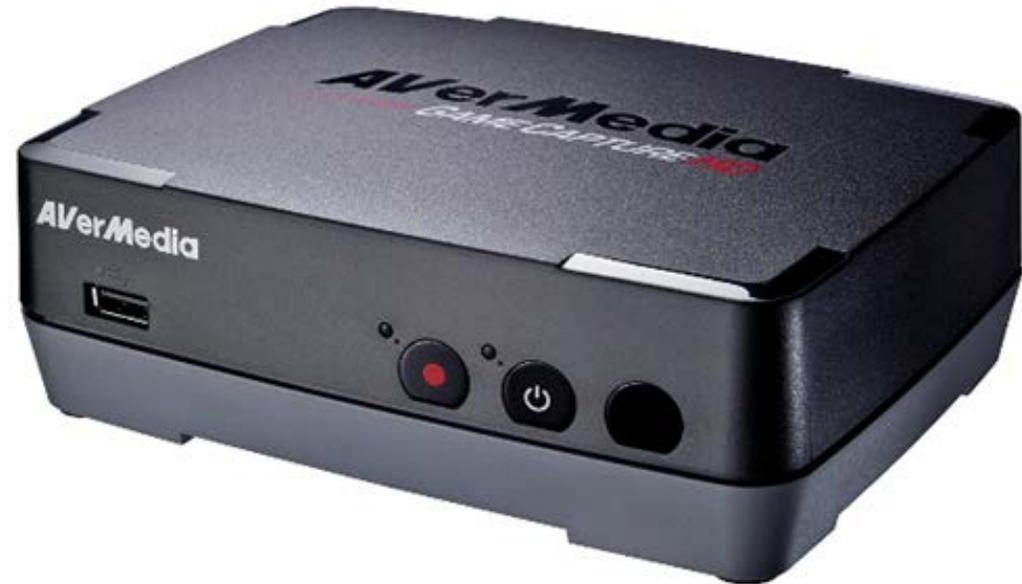
Solution

AverMedia Video Game Recorder - ~\$100

- In-line video recording hardware that records directly to USB. (HDMI in/HDMI out)
- Able to monitor exactly what is being recorded and playback/delete files easily
- Simple interface
- Easily transfer files
- Verify power off for NRC exam security

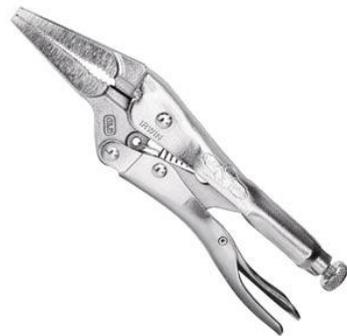
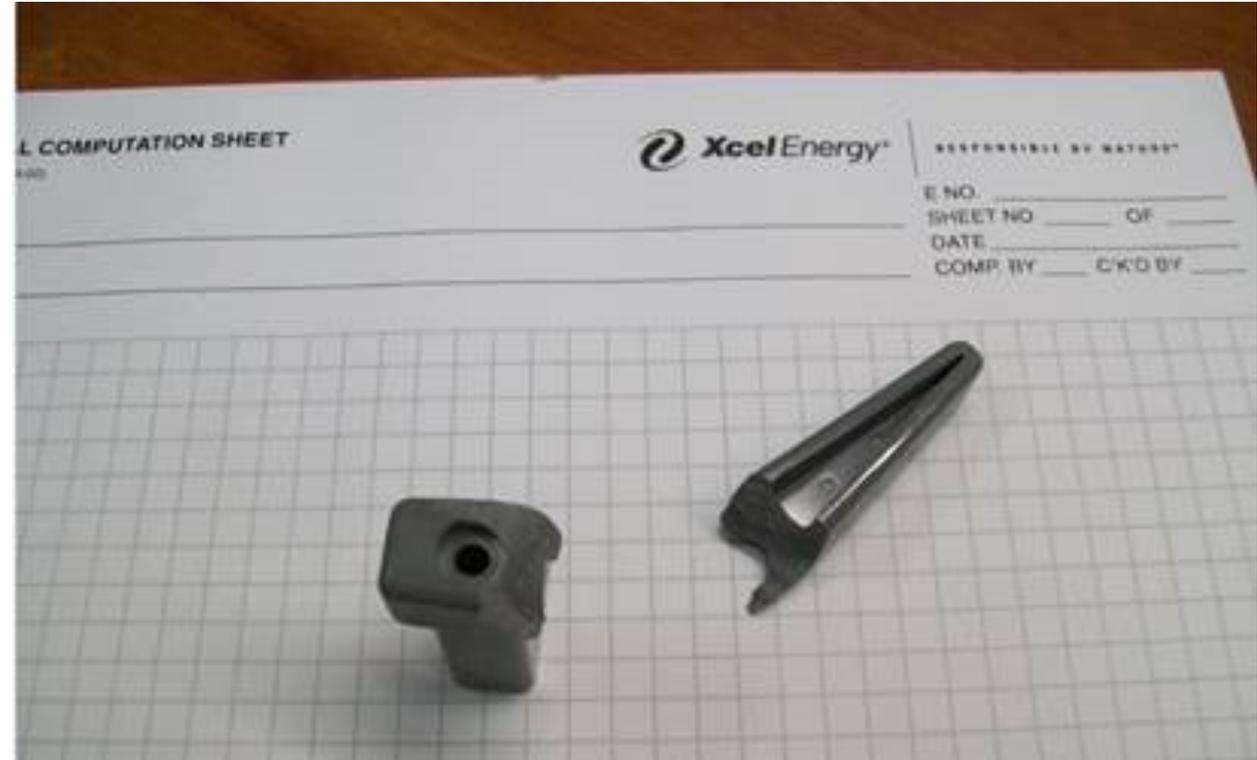
Safety Related Switch Handles

- Original Equipment safety related switch handles have been breaking for 20 years.
- Traditional solution was to purchase OEM qualified switch handles for \$1000 each.
- Resulted in a first-aid case. Blood on the control panel is not good.
- Contingency was...

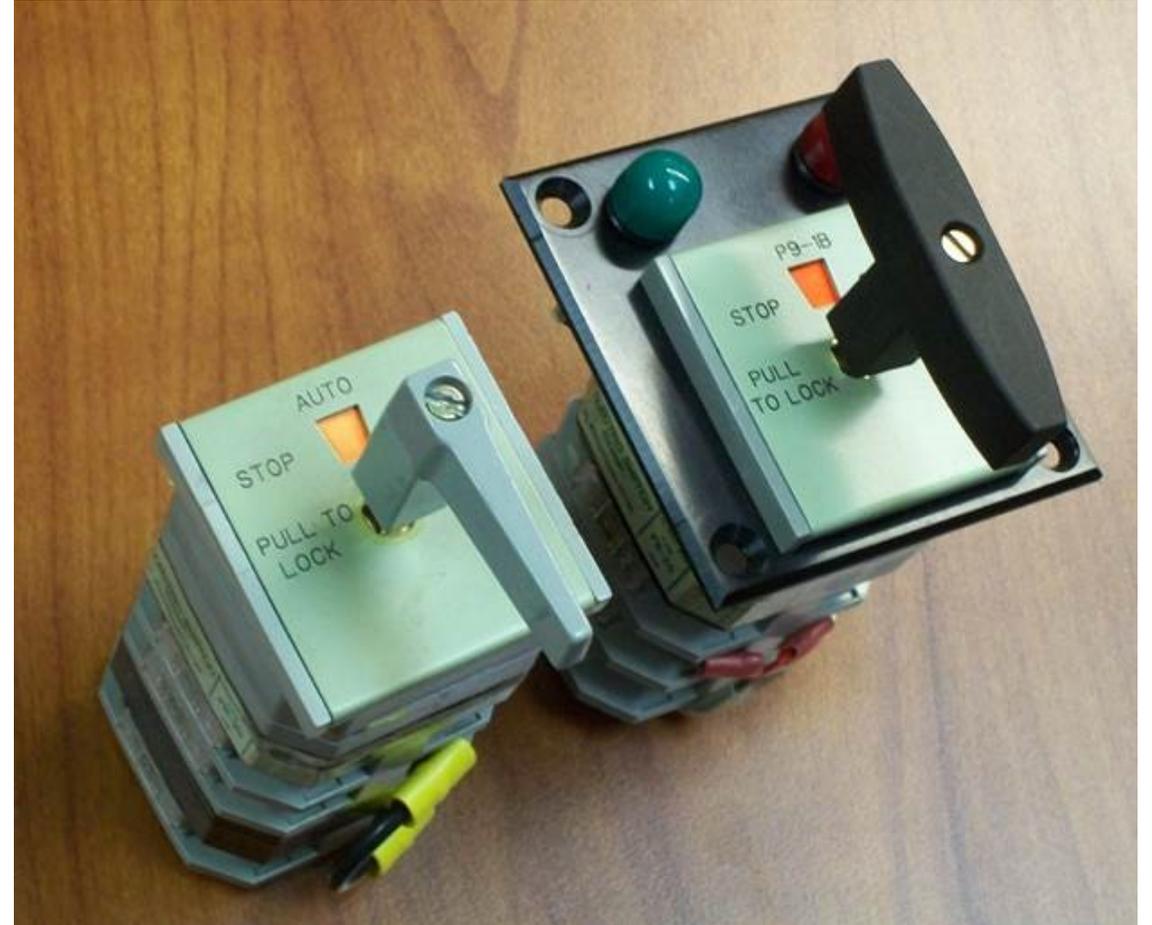
Safety Related Switch Handles

- New design is created and shipped within days from the vendor.
- Material specifications are detailed, tested and significantly better than OEM.
- New failure mechanism; the shaft is the weakest link.
- Per unit cost...\$12.
- A savings of \$988/unit for approximately 100 units in the control room; delivering the nuclear promise.

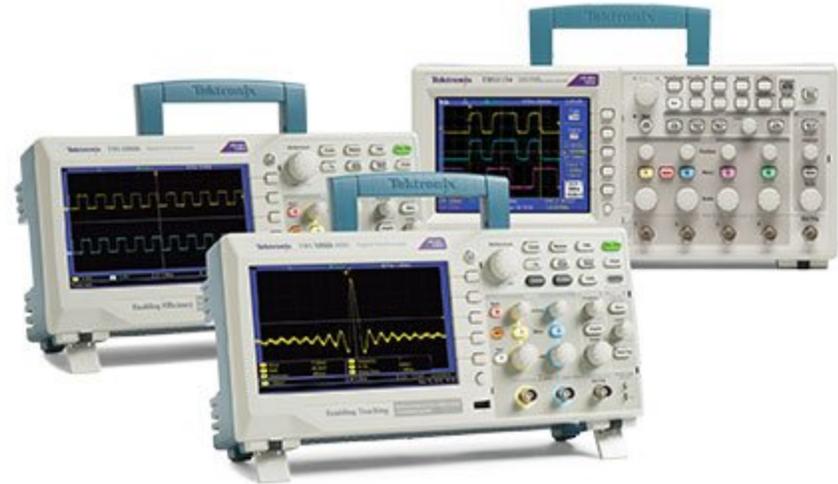
PWR Step Counter Issue

- During manual insertion of rods, occasionally, in a somewhat repeatable fashion, the step counters would incorrectly display the rod position.
- Step counters use a pulsed signal to toggle the rod position.
- Standard 100 mSec pulse, 50 mSec high and 50 mSec low.
- Strobe signals less than 75 mSec are ignored. Strobe signals greater than 150 mSec could be counted twice.
